Sika at Work

Fast Introduction of **Sikafloor[®]-PurCem[®]** in North and Latin America Case Studies

Best demonstrated Practice Sikafloor®-PurCem® Introduction into North and Latin America

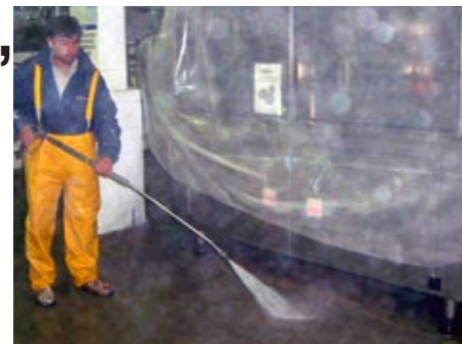
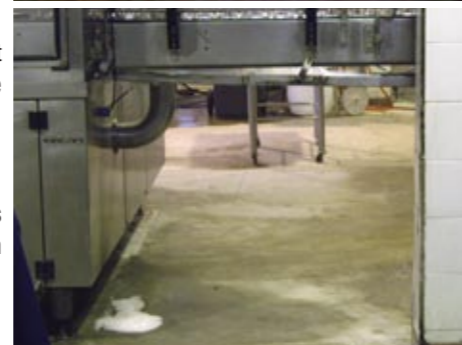
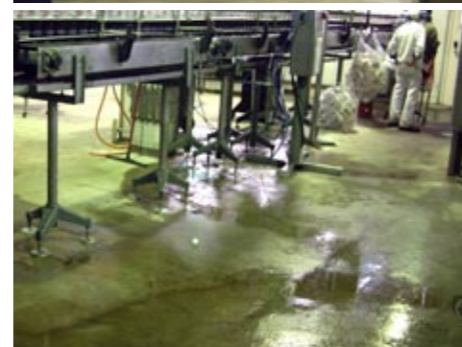
Coca Cola Polar, Bahía Blanca, Argentina

360 m² of bottling area floor that was previously tiled.

Removal of the tiles and fixing mortar and preparation of the substrate. High ambient moisture (66% r.h.) and substrate moisture (4.4%) and low ambient and substrate temperature (12°C).

Sikafloor®-21N PurCem® in a total thickness of 4 mm for the 360 m² area, plus approximately 20m² for detailing and coving with **Sikafloor®-29N PurCem®** also in 4 mm. **Sika® Rod, Sikaflex® Pro-3 WF.**

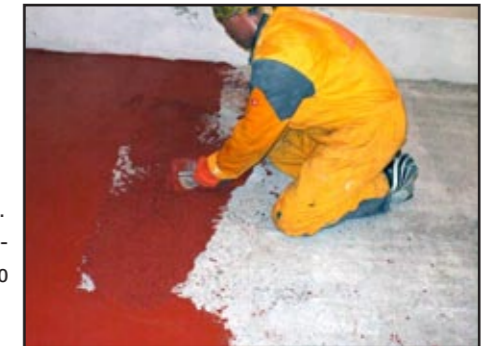
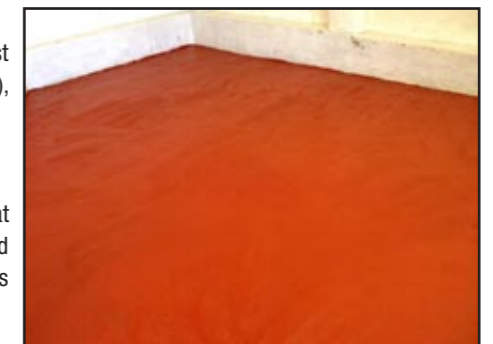
Norson, in Hermosillo, Sonora, México

Pork production facility for raising, fattening, slaughtering, processing and packaging. 7 blast-freezer chambers 100 m² each for a total of 700 m². Production and processing areas will be treated in the future. Almost 100% of the plant's production goes to Japan and China.

The freshly processed and packaged meat is introduced into the freezers which are at around 8°C, and in just 3 minutes, they are frozen down to -35°C, then extracted and replaced by the next batch. This takes about 20 minutes. By then, the temperature has risen again to around 8°C and the freezer doors are closed and another cycle begins.

Sikafloor®-19N PurCem® at 7.5 mm thick.

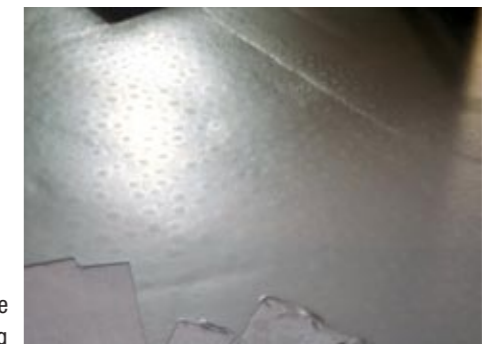
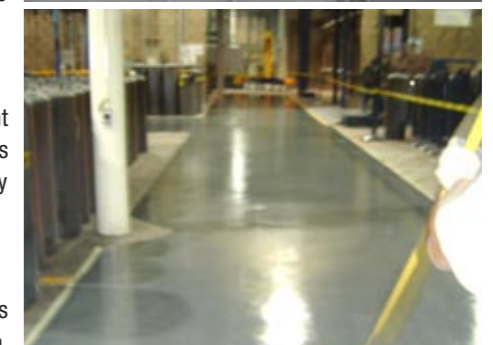
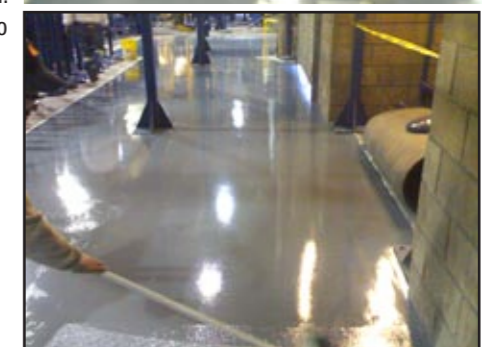
Rheem Water Heaters, S de R.L. de C.V., Mexicali, México

Extremely high service temperatures at the furnace entrances, where the cylinders are formed, in what already is a high ambient temperature. Heavy abrasion from rolling and movement of the cylinders plus frequent heavy forklift traffic.

Ambient temperatures in May to July of 52°C to 56°C in the shade. Winter ambient temperatures of -14°C to 4°C. (A real desert climate). Extremely short application times and very fast product reaction which caused blistering of the first (unsupported by Sika) application by the "contractor".

The use of an air-conditioned office for product storage (+27°C), plus placing of parts A and B in ice water prior to mixing, (material conditioning), and application at 4 a.m. with 29°C air temperature, 31°C in the substrate and 2 minute mixing, allowed to apply in a single layer 6 mm of **Sikafloor®-21N PurCem®**.

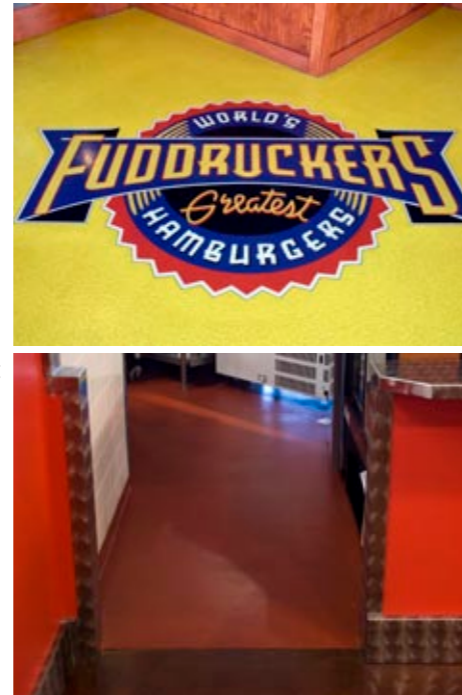
Fuddruckers Restaurant, Denton, Texas, USA

A new kitchen, entrance and queue lines. Kitchen 1425 sq.ft (132,4m²) and 350 linear ft. (106.7m) of 4 inch coving (10 cm). Entrance and queue line area 500 sq. ft (46.5 m²).

Kitchen area: **Sikafloor®-22N PurCem®** medium to heavy duty, self levelling broadcast screed and **Sikafloor®-29N PurCem®** coving and detailing mortar and **Sikafloor® -31N PurCem®**, solvent free, matt finish coating.

The entrance and queue line area **Sikafloor®-261** with decorative flake system and company logo, sealed with **Sikafloor® 2002** and **Sikafloor® Polythane UV**.

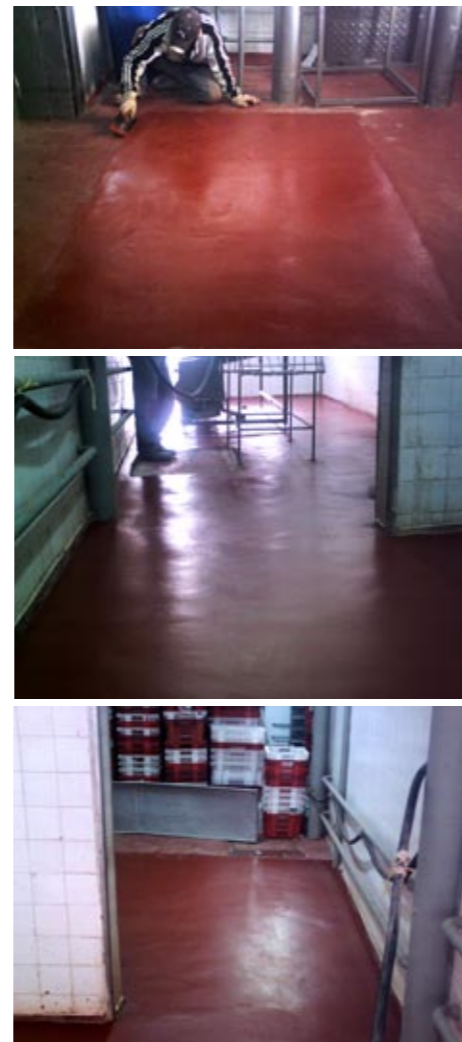
Quickfood, San Luis, Argentina

200 m² in a cold storage area of meat processing plant. 1090m² in dry process area and aisles.

In the cold storage area, **Sikafloor®-19N PurCem®** at 8mm thick. Cutting out of joints and placing of **Sika® Rod, Sikaflex® Pro-3 WF**. In the dry process area and aisles: **Sikafloor®-21N PurCem®** at 4mm thick.

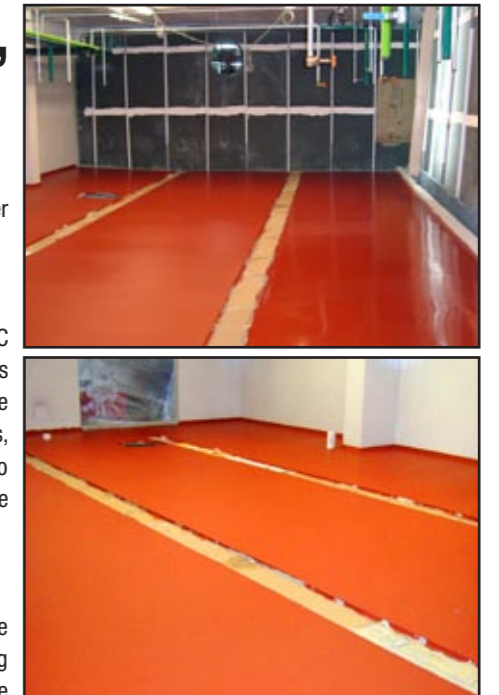
Industrias Golden S.A. de C.V., México D.F., México

An industrial textile tannery, requiring concrete floor protection against very hot water with high chemical dye content, 600 m².

The floor was designed with a slope of 2% into the drains (which also had to be protected) and there was a risk that the material would slump into the drains during application, but which did not occur. The customer is aware that some staining of the screed is to be expected, but cleaning with lukewarm water under pressure three times a day will minimise the matter.

Sikafloor®-21N PurCem® at 6 mm thick in a single layer application.

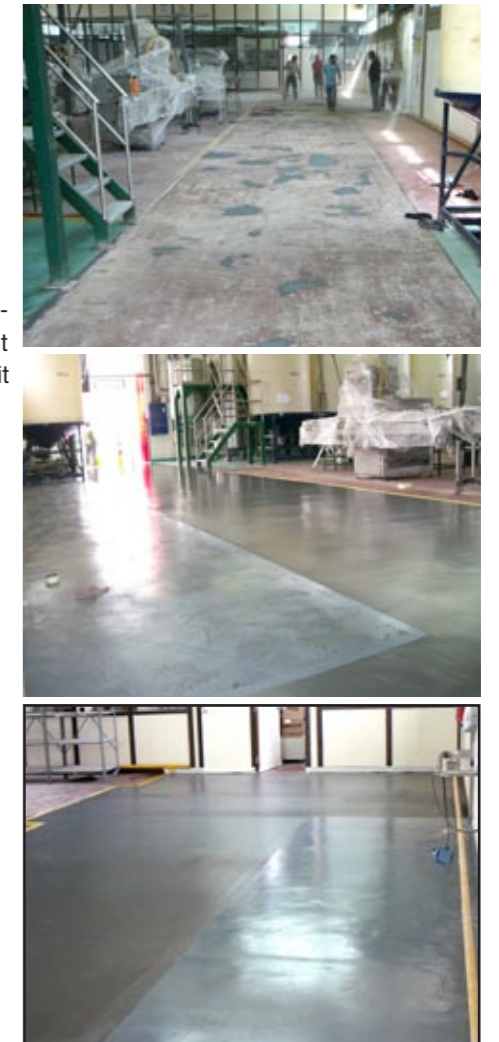
Syntaric, Buenos Aires, Argentina

The refurbishment of a deteriorated epoxy mortar screed aisle, which had been repaired and overpainted several times, due to the extreme mechanical abrasion it suffers. This is caused by the great amount of merchandise transport carts using it constantly.

Sikafloor®-21N PurCem® in 4 mm.

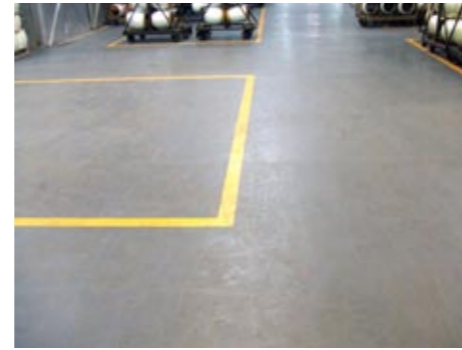
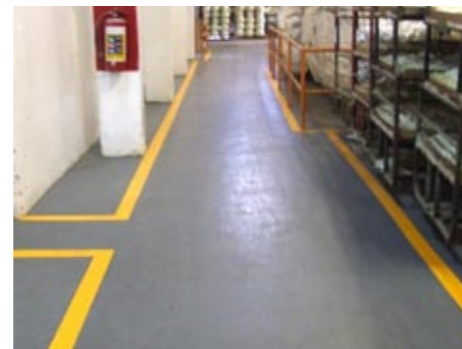
Owens Corning, S.A. de C.V., México D.F., México

The carts weighing up to 3 tonnes transport several fibreglass rolls, right after production at about 70°C to 90°C. At the furnace doors there is a strong thermal shock to be added to the traffic. There is a lot of fine fibre glass from the weaving and threading of the fibreglass (in dust form) so with an easy to clean floor, it is simple to collect it and reprocess it.

Sikafloor®-19N PurCem® at 6 mm thick.

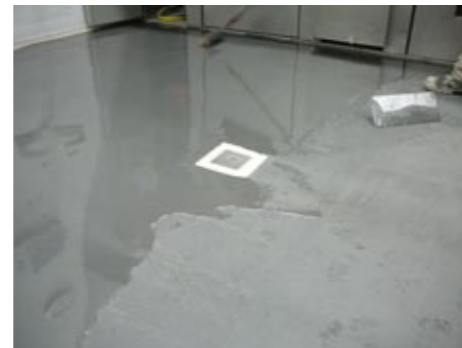
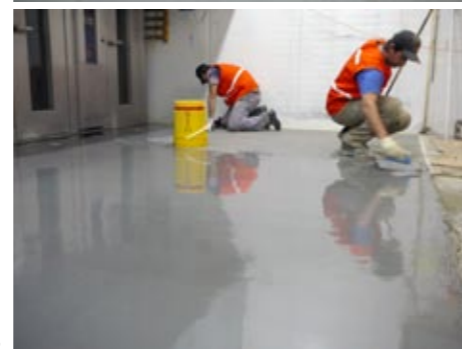
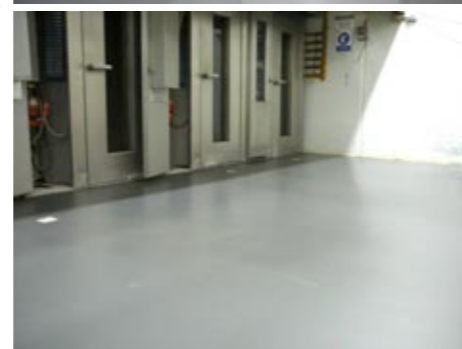
Sapore di Pane, Buenos Aires, Argentina

High substrate moisture, joint repair and levelling required before the screed placing.

Sikafloor®-21N PurCem® at 4 mm. **Sika® Patch Primer**, **Sika® Patch Mortero**, **Sika® Rod**, and **Sikaflex® Pro-3 WF**.

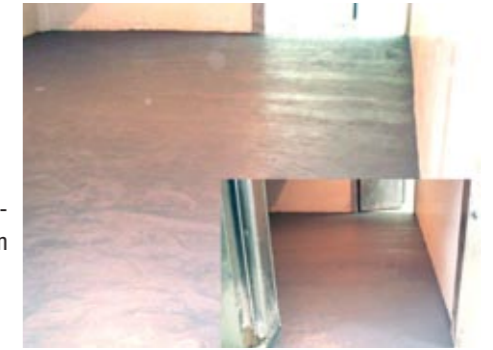
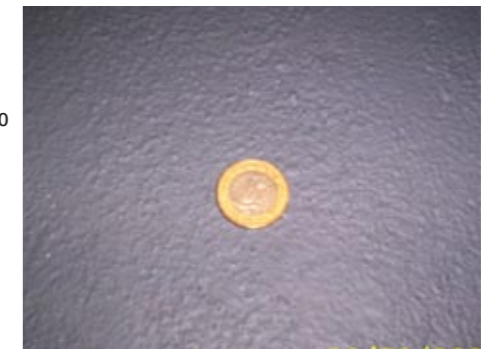
Frutos Marinos, S.A. de C.V., Guaymas, Sonora, México

240 m² in 3 blast freezers (80m² each), in a plant for the processing and sale of seafood. They receive the majority of the shrimp from the local port of Guaymas, and then clean, process, wash and package for export to the USA.

The shrimp is frozen from 8°C to -40°C in just 3 minutes, and it is then stored for up to a year, until it is shipped to the USA.

Sikafloor®-19N PurCem® at 7.5 mm thick in grey colour.

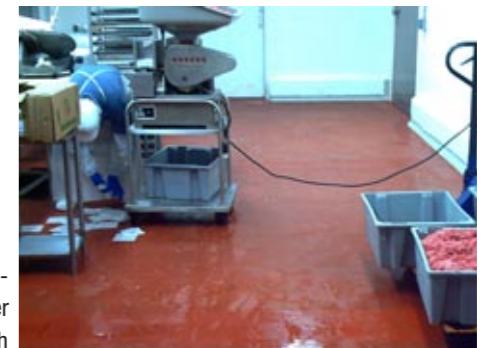
Empacadora de Carnes de Tijuana S.A. de C.V., Tijuana, México

950 m² in a meat processing and packaging plant. The process starts with the reception of the previously slaughtered cows, cut in half, which are then cut into finer pieces. Destined for national and export (USA) consumption. Fully wet process, with continuous water and fat spills. At the end of each day the floor is cleaned with hot water jet and paracetic acid as disinfectant.

Hygienic grade floor for food industry, slip-resistant for wet processes and hot water cleaning and high abrasion resistance.

Sikafloor®-19N PurCem® at 6 mm thick in one application.
